Thermal Imaging Infrared Survey Report Sample.

Thermography Inspection at
ABC Company.

Vancouver, BC

Rick Turdubay, **Certified Infrared Investigator,**
B.S. in Electrical Engineering.

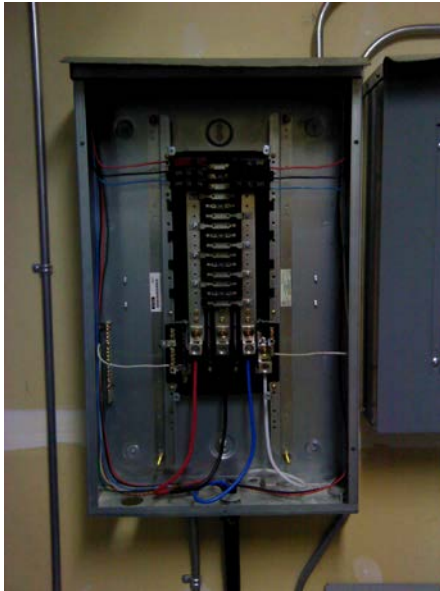
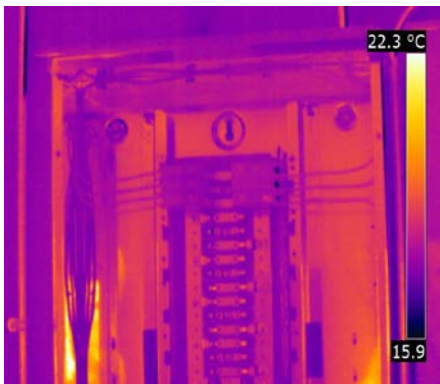
Location	Electrical Room
Equipment	House Panel ,120/208V, 225A
Type	Incoming lugs:120/208V
Nom/Rated Load	225A
Actual Load	Phase: A=0.3A; B=0; C=0.6A, Load is under 3%,
Fault	Fault Rating: Loads =under 3%, Not possible to analyze. Room Temp. C =19.7; Reflected Temp.=18.2 Rel. Humidity= 53% Emissivity= 0.95; Distance=2m See IR picture.

All phases' loads are too small, under 3% of the nominal/rated load. **Not possible to analyze.**
Recommendation: Book another survey when an acceptable (at least 50% of the normal rate) load is available.

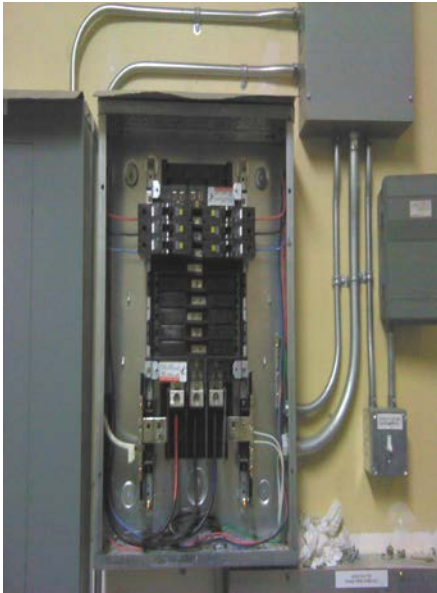
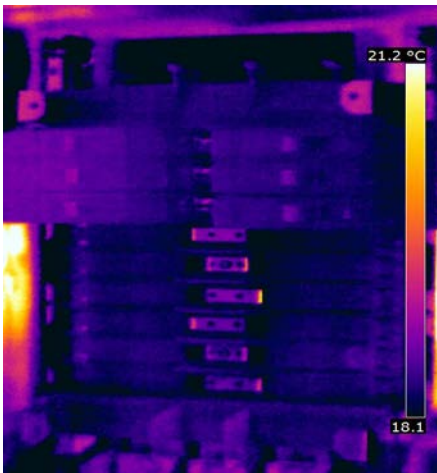
Location	Electrical Room
Equipment	House Panel ,347/600V, 125A
Type	Incoming lugs, 347/600V
Nom/Rated Load	125A
Actual Load A	Phase: A=0; B=0; C=0
Fault	Loads =0; Not possible to analyze. Room Temp. C =19.7; Reflected Temp.=18.2 Rel. Humidity= 53% Emissivity= 0.95; Distance=2m See IR picture.

All phases' loads are equal 0 (zero). **Not possible to analyze.**

Recommendation: Book another survey when an acceptable (at least 50% of the normal rate) load is available.

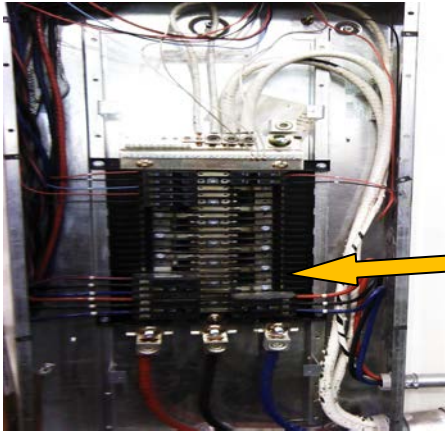
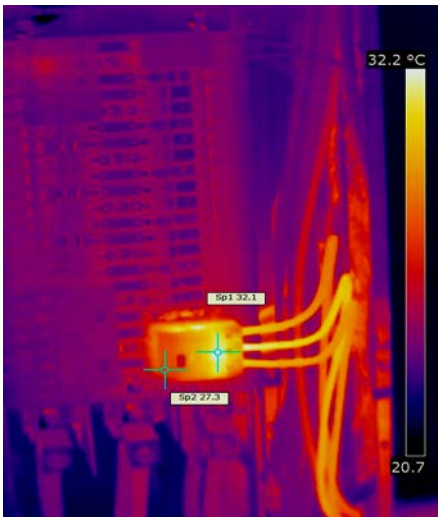
Location	Main Building
Equipment	Panel 4A, 120/208V, 400A
Type	Incoming lugs:120/208V
Nom/Rated Load	400 A
Actual Load :A	A=42; B=61;C=42
Type	Circuit Breakers:
Nom/Rated Load	CB # 38-40-42 3Phase;100A
Actual Load: A	A= 44A; Load %= 44 B =46A; Load %= 46 C= 40A; Load %= 40 Room Temp. C =23.5; Reflected Temp.=23.1 Rel. Humidity= 48.7% Emissivity= 0.95; Distance=2m
Fault	Fault Rating: 1: Low grade Spot1.Temp =32.1, Spot2=27.5; Tem. rise ΔT 4.6 °C, See IR picture.

Fault Suggestion: The $\Delta T < 5$ °C. However, the corrected maximum allowable temperature for the circuit breaker # 38-40-42 at the existing actual phase loads and room t °C is 29-30°C. The operating t°C=32.1
See calculation formula on the last page of the report.

3Phase CB # 38-40-42; Nominal rate: 100A. Actuals: A= 44A; Load %= 44; B =46A; Load %= 46; C= 40A; Load %= 40
Spot1.Phase B, Temp =32.1, Spot2=27.5; Tem. Rise ΔT = 4.6 °C. **Fault Rating: 1: Low grade.** See the suggestion above.
Recommendation: The CB to be monitored.

The 3Phase CB # 38-40-42 of the Panel 4A is found to be operating at a temperature of 32.1°C.

The measured ambient temperature (Tambmeas) = 23.5°C. The circuit breaker (CB) is rated at 100 amps (Arated) but its actual average load is measured at only 43.33 amps.

$$Tmaxcorr = \{(43.33 \div 100)^2 \times (30)\} + 23.5 = \{(0.43)^2 \times (30)\} + 23.5 = \{(0.18) \times (30)\} + 23.5 = 29.5$$

The actual operating temperature of the CB (32.1°C) is greater than the Tmaxcorr of 29.5°C.

This is an exception!

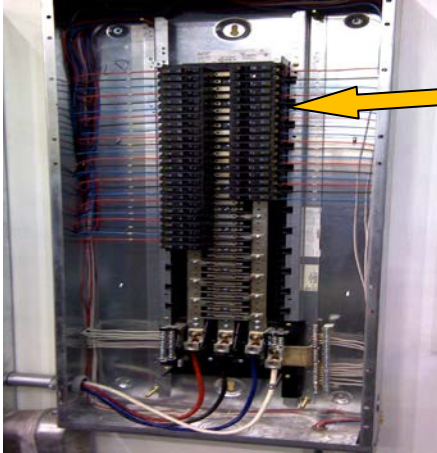
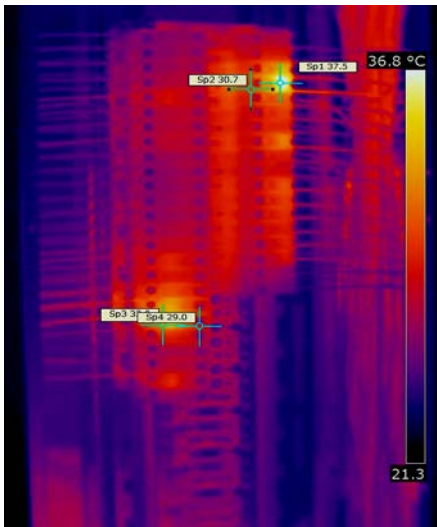
Location	Main Building
Equipment	Panel 4B , 120/208V, Rated:225A Incoming lugs loads: A=35A, Load %=15 B=45A, Load %=20 C=41A, Load %=18
Type	Circuit breakers
Nom/Rated Load	15 A
Actual Load	Max. load on the CB # 8 Load =10 A; Load %= 66 CB# 39 ; Load= 9A; Load %= 60 Tem. Rise $\Delta T = 4^{\circ}C$ Room Temp. C =23.5; Reflected Temp.=23.1 Rel. Humidity= 48.7% Emissivity= 0.95; Distance=2m
Fault on the CB# 8	Fault Rating: 1: Low grade Spot1.Temp =37.5, Spot2=30.7; Tem. rise $\Delta T = 6.8^{\circ}C$ See IR picture.

CB # 8: Spot1.Temp =37.5, Spot2=30.7; **Tem. Rise $\Delta T = 6.8^{\circ}C$. Fault Rating: 1: Low grade.**
Recommendation: the CB # 8 to be monitored.

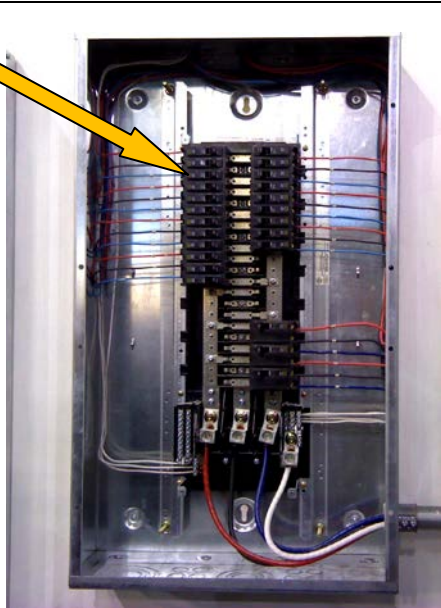
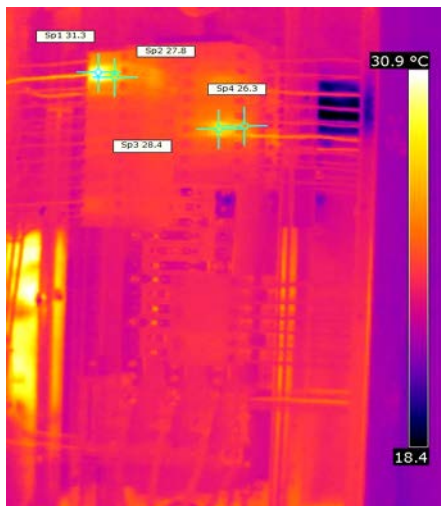
Location	Main Building
Equipment	Panel 2C, 120/208V, 225A
Type/Nom. Load	Main lugs-225 A
Actual Load:	A=1A; B=21A; C=23A Load unbalanced
Type	Circuit breakers
Nom/Rated Load	15 A
Actual Load	CB #3, Load=1A; Load %=6 CB #6, Load=4A; Load %= 26 Room Temp. C =23.5; Reflected Temp.=23.1 Rel. Humidity= 48.7% Emissivity= 0.95; Distance=2m
Fault	Fault Rating: 1: Low grade. CB #3; Spot1 t°C =31.3, Spot2=27.8; Tem. rise ΔT = 3.5 °C, CB #6; Spot3 t°C =28.6, Spot4=26.3°C; ΔT = 2.3 °C,

Fault Suggestion: CB# 3, the $\Delta T < 5$ °C. However, the corrected maximum allowable temperature for the circuit breaker # 3 at the existing actual load =1A and room t °C is 23-24°C. The operating t°C=31.3
See calculation formula on the last page of the report.

Fault Rating: 1: Low grade. See the fault suggestion above.
Incoming lugs phases loads somewhat **unbalanced** at A=1A; B=21A; C=23A
Recommendation: the CB # 3 to be monitored.

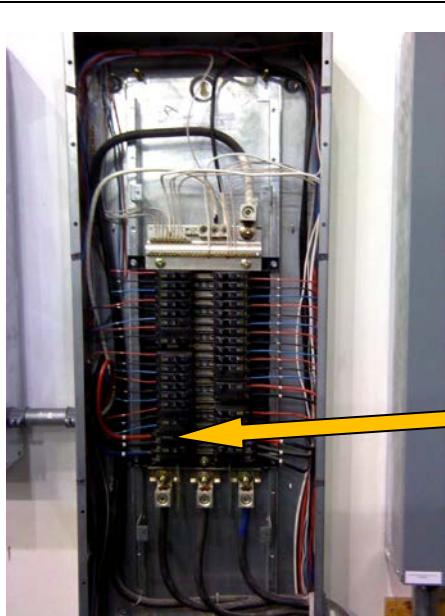
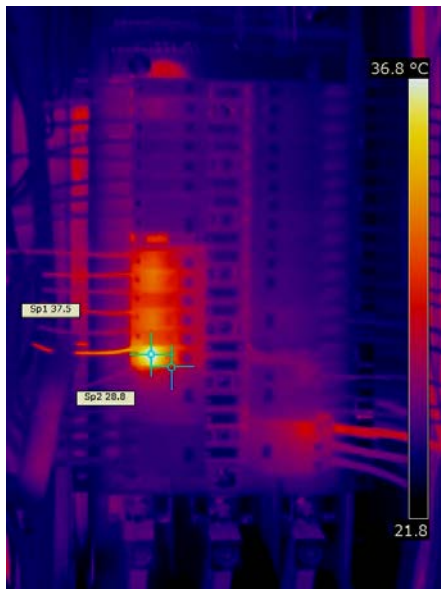
Location	Main Building
Equipment	Panel 2A, 120/208V, Rated :400A Actual load: A=80A;B=50A;C=60A
Type	Circuit breakers
Nom/Rated Load	20 A
Actual Load	Circuit Breaker #29 Load = 15 A; Load %= 75 Spot1 t°C =37.5, Spot2=28.8; Tem. rise ΔT= 8.7 °C, Circuit Breakers # 21 and 25 Load jumping between 4÷17A; Room Temp. C =23.5; Reflected Temp.=23.1 Rel. Humidity= 48.7% Emissivity= 0.95; Distance=2m
Fault on the CB#29	Fault Rating:1 Low grade See IR picture.

Circuit Breaker #29; Load = 15 A; Load %= 75. Spot1 t°C =37.5, Spot2=28.8; **Tem. rise ΔT= 8.7 °C,**
Fault Rating: 1: Low grade
Recommendation: the CB # 29 to be monitored.

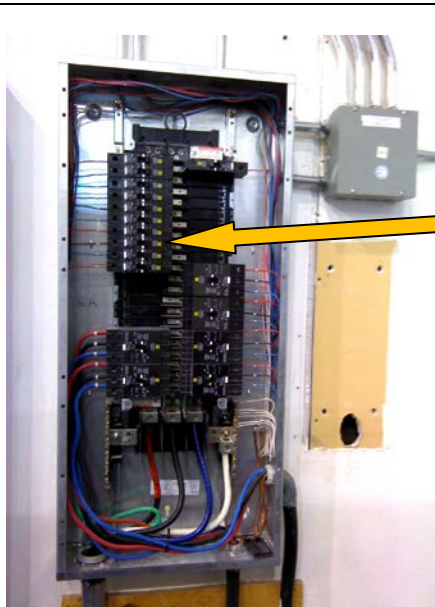
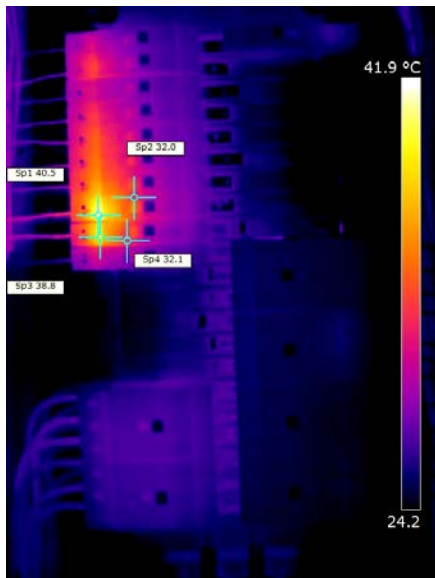
Location	Main Building
Equipment	Panel 6A, 347/600V, Rated :250A Actuals=66A;B=73A;C=70A
Type	Circuit breakers
Nom/Rated Load	15 A
Actual Load	Circuit Breaker #15 Load = 11A; Load %= 73 Spot1 t°C =40.5, Spot2=32.0; Tem. rise ΔT= 8.5 °C Circuit Breaker #17 Load = 11A; Load %= 73 Spot1 t°C =38.8, Spot2=32.1; Tem. rise ΔT= 6.7 °C
Fault on: CB# 15 and CB#17	Fault Rating: 1 Low grade Room Temp. C =23.5; Reflected Temp.=23.1 Rel. Humidity= 48.7% Emissivity= 0.95; Distance=2m See IR picture.

Circuit Breaker #15, Tem. rise $\Delta T = 8.5 \text{ }^\circ\text{C}$; Circuit Breaker #17 Tem. rise $\Delta T = 6.7 \text{ }^\circ\text{C}$. **Fault Rating: 1 Low grade.**
Recommendation: the CB # 15 and CB# 17 to be monitored.
