High Voltage Electrical Equipment Thermal Imaging /Infrared Survey Report Sample.

**Thermography Inspection at
(ABC Company).**

By Rick Turdubay, Certified Infrared Investigator.

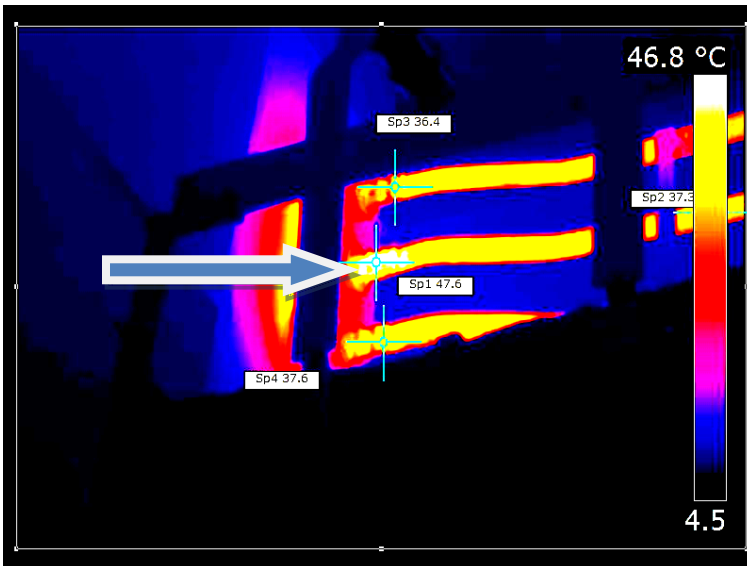
Location	Distribution Substation " Centre" at 35/6 kV level
Equipment	Indoor Switchgear ,35/6 kV level
Type	Bus duct # 6
Nom/Rated Load	1000A
Actual Load	1100A Phase loads not provided
Fault	Fault Rating: 2 Max. Temp °C =46.7, Min=4, 4 Temp. rise between the phase B bus and its bolted joint is 10.4 °C (Sp1=46.7; Sp2=37.3)

Phase loads unknown/not provided. As per the customer's information actual load is =110%. It seems the phase B bolted connection is loosed or has corrosion. Temp. rise between the phase B bus and its bolted joint is 10.4°C. This might be considered a level 2, **Repair at scheduled shut down**. Contact your service company to plan a preventive action.

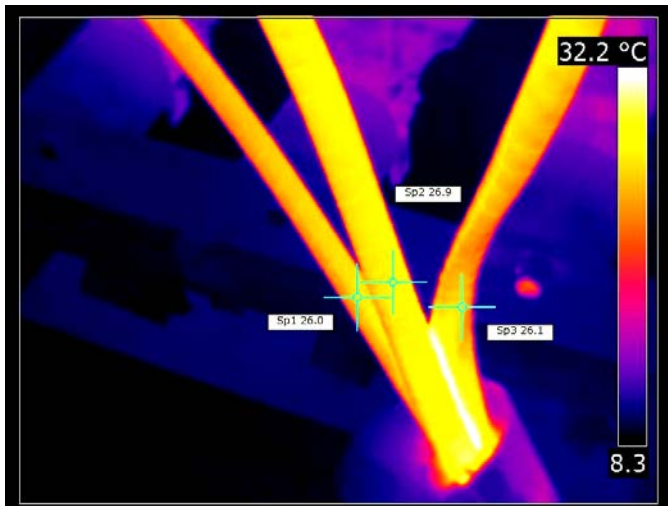
Location	Distribution Substation " Centre" at 35/6 kV level
Equipment	Switchgear cubicle# 10,Switch B6
Type	Feeder # 10
Nom/Rated Load	630A
Actual Load	300A Phase loads not provided
Fault	Fault Rating: 0, Normal Max. Temp °C =26.9, Min=8, 2 Temp. rise between the phases A and B is 0.9 °C (Sp1=26.0; Sp2=26.9,Sp 3=26.1) See IR picture.

Phase loads unknown/not provided. As per the customer's information actual load is =50%. Temp. rise between the phases A and B is 0.9 °C. This might be considered a **level 0, Normal**.

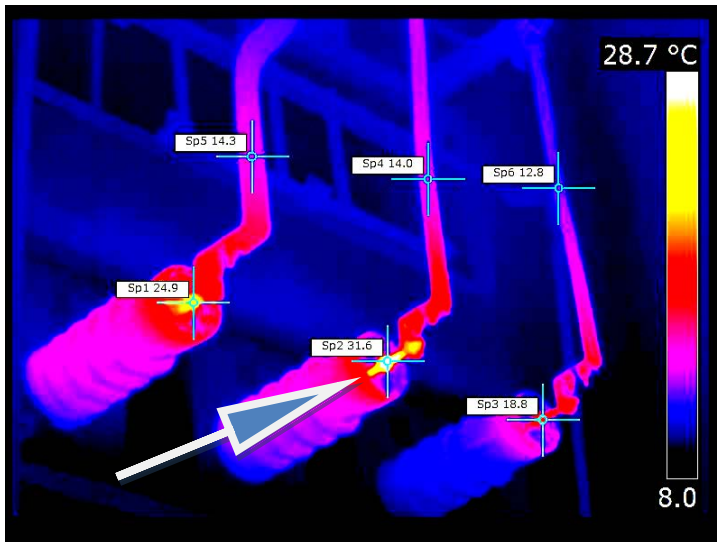
Location	Distribution Substation " Centre"# 4 at 35/6 kV level
Equipment	Bushing 35kV, Transformer #1
Type	Bushing insulator
Nom/Rated Load	630A
Actual Load	Actual and phase loads not provided.
Fault	Rating: 2 Max. Temp °C =31.9, Min=7.8 Temp. rise between the phase B bus and its bolted joint is 27.6 °C (Sp2=31.6; Sp4=14) (Sp1=24.9; Sp5=14.3) See IR picture.

Actual and phase loads unknown/not provided. Temp. rise between the phase B bus and its bolted joint is 27.6 °C. It seems the phase B bolted connection is loosed or has corrosion. This might be considered a level 2. **Repair at scheduled shut down.** Contact your service company to plan a preventive action.

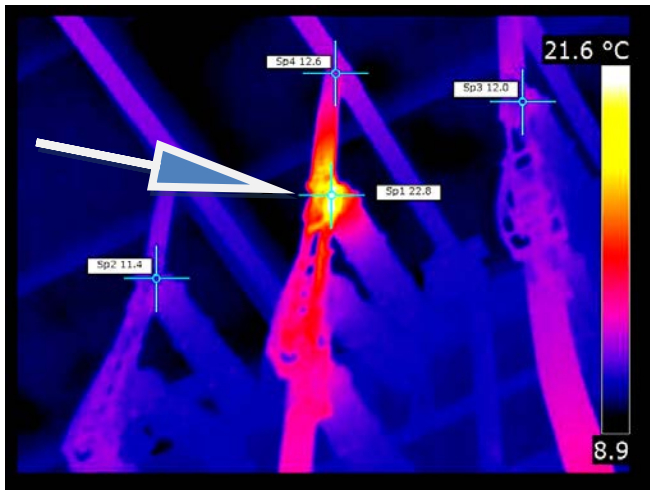
Location	Distribution Substation " Centre" # 4 at 35/6 kV level
Equipment	Transformer #1, 35 kV disconnecter
Type	Blade contacts
Nom/Rated Load	630A
Actual Load	Actual and phase loads not provided.
Fault	Rating: 2 Max. Temp °C =22.8, Min=8.8 Temp. rise between the phase B blade contact and its bolted joint is 11.2 °C (Sp1=22.8; Sp4=12.8) See IR picture.

Actual and phase loads unknown/not provided. The temp. rise between the phase B blade contact and its bolted joint is 11.2 °C. It seems the phase B blade contact connection is loosed or has corrosion. This might be considered a **level 2**.
Repair at scheduled shut down. Contact your service company to plan a preventive action.

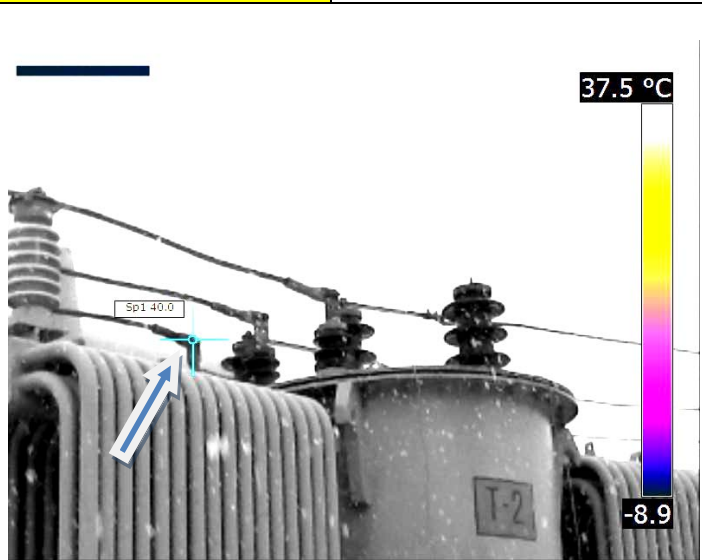
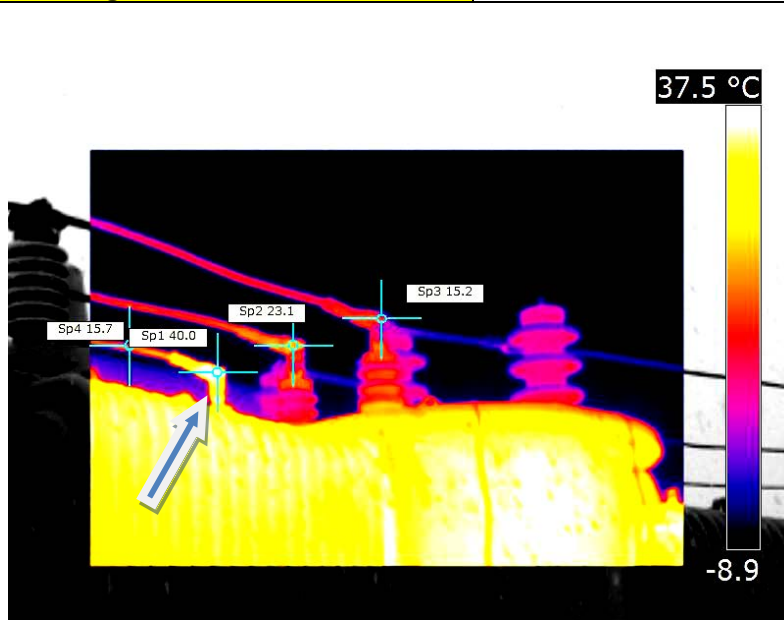
Location	Distribution Substation " North "at 35/6/10 kV
Equipment	Bushing 10kV, Transformer #T2/6600 kVA
Type	Phase C
Nom/Rated Load	1000A
Actual Load	650A, Phase loads not provided.
Fault	Rating: 2 The temp. rise between the phase C bushing insulator and its conductor is 23.1 °C (Sp2=21.3; Sp3=15.2) (Sp1=40; Sp4=15.7) See IR picture.

Phase loads unknown/not provided. Actual load is 65%. The temp. rise between the phase C bushing insulator and its conductor is 23.1 °C . It seems the connection between the phase C bushing insulator and its conductor is loosed or has corrosion. This might be considered a **level 2. Repair at scheduled shut down.** Contact your service company.

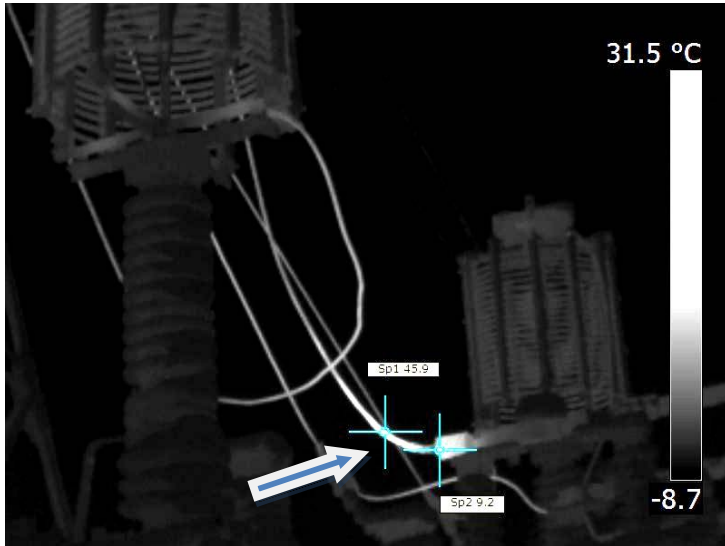
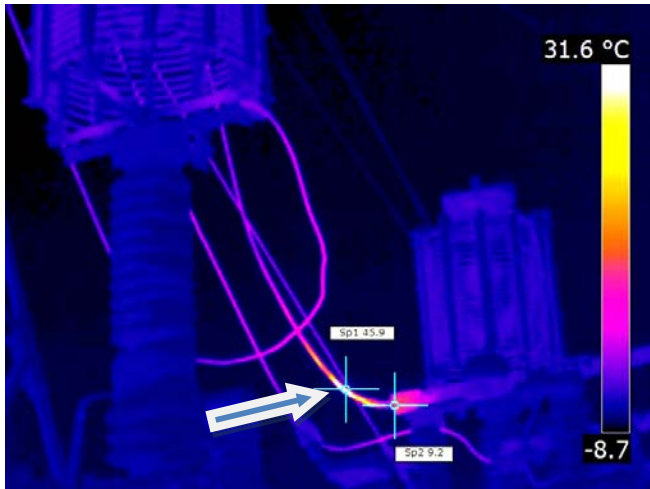
Location	Distribution Substation " North "at 35/6/10 kV
Equipment	Feeder disconnect, 35 kV, Transformer #2
Type	Phase C
Nom/Rated Load	1000A
Actual Load	650A Phase loads not provided
Fault	Rating: 3 The temp. rise between the disconnect phase C and the contact wire line/conductor is 36.7 °C (Sp1=44.9; Sp2=9.2) See IR picture..

Phase loads unknown/not provided. Actual load is 65%. The temp. rise between the disconnect phase C and the contact wire line/conductor is 36.7 °C. It seems the contact wire line/conductor consists 2 pieces of conductors connected by bolted joints. This might be considered a **level 3. Repair immediately** .Contact your service company.
